Periodic Inspection of Nawiliwili Harbor Breakwater, Kauai, Hawaii

Report 1

Base Conditions

by Robert R. Bottin

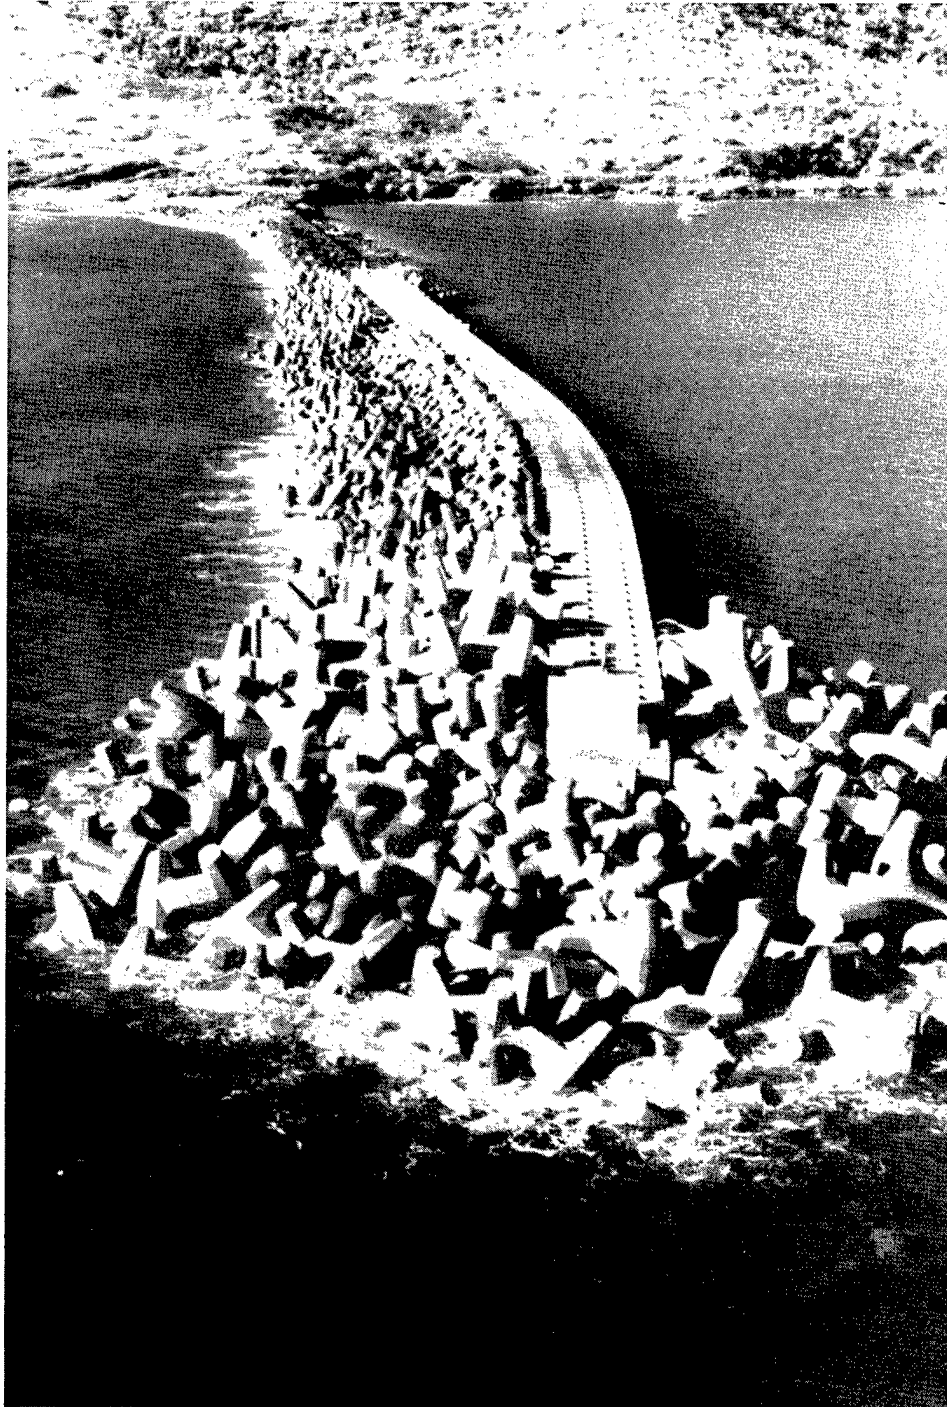
Hurricane Iniki struck the island of Kauai in 1992 with Nawiliwili almost directly in its path. Eyewitness accounts indicated that seas outside the harbor reached 10 m (33 ft) during the storm and over 3 m (10 ft) inside the harbor. Storm surge exceeded 5 m (16 ft) along much of the southern island coast. A survey revealed that three 20,865-kg (23-ton) dolosse, seven 9,980-kg (11-ton) dolosse, and six 16,150-kg (17.8-ton) tribars had broken as a result of the hurricane. A survey of the structure in 1994 revealed a total of 54 broken concrete armor units on the structure above the waterline. An aerial photo of Nawiliwili breakwater in 1995 is shown in Figure 7.

Figure 7. Aerial photograph of Nawiliwili breakwater (1995)

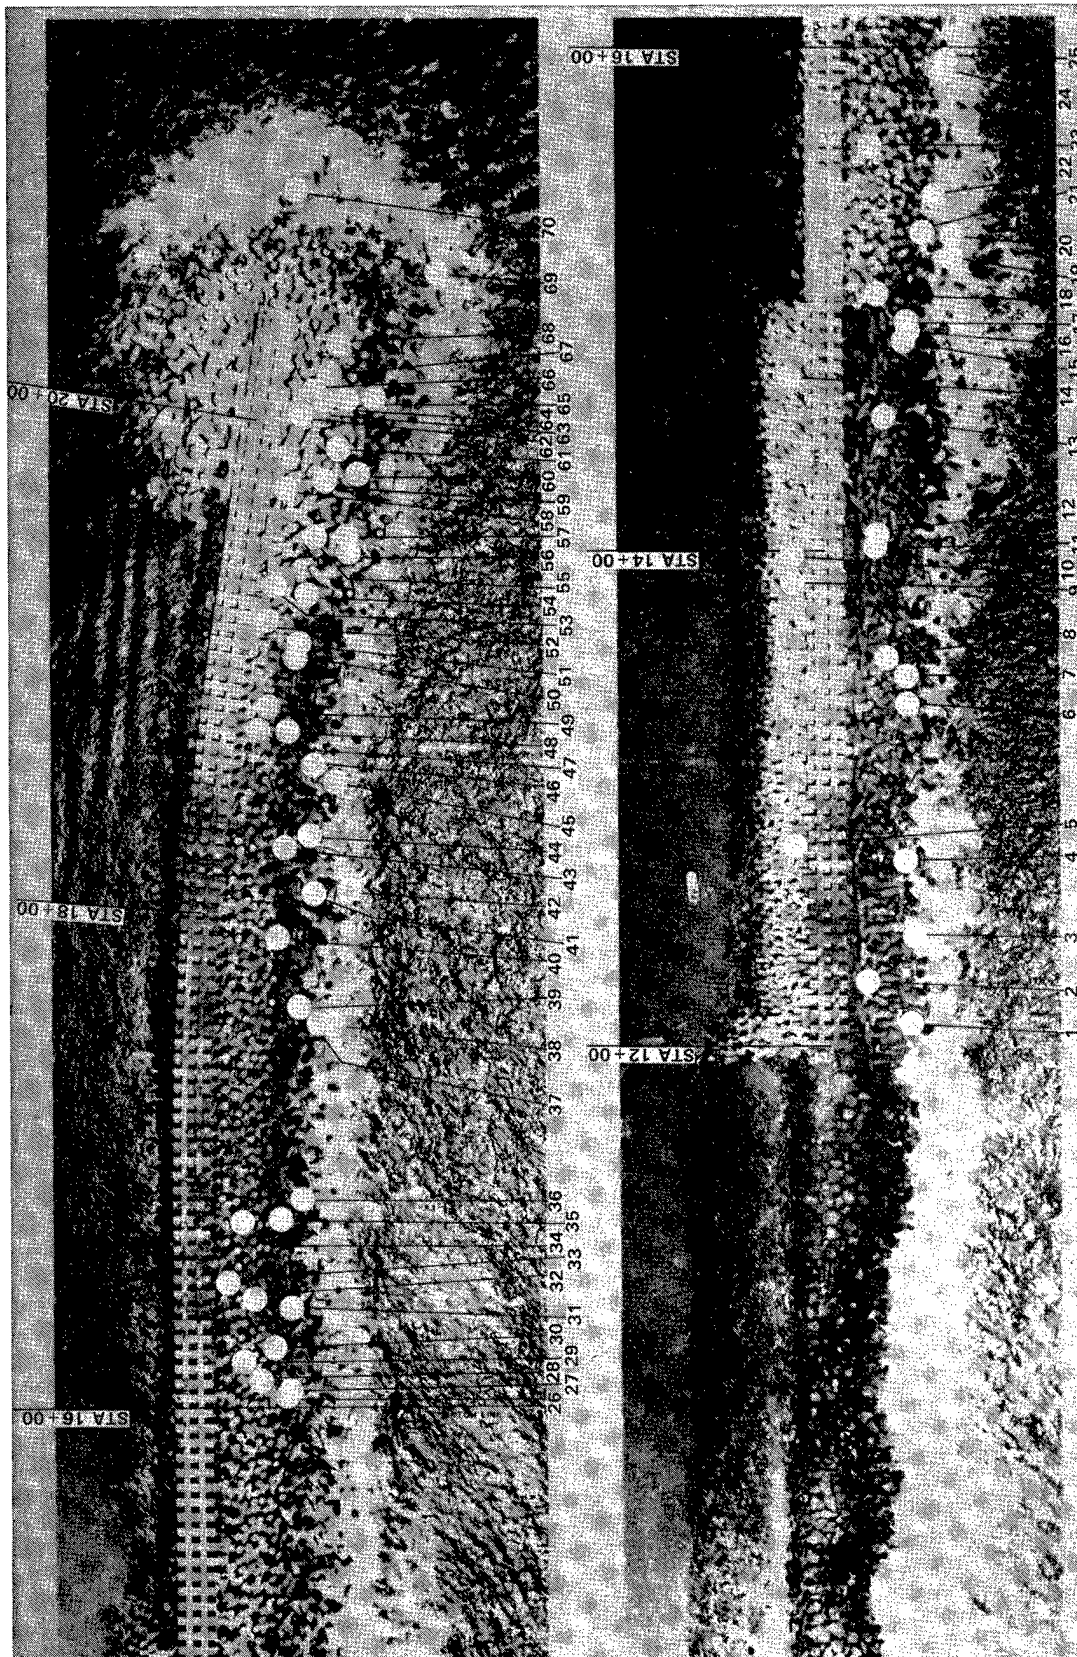
The approximate locations of broken/cracked armor units along the outer portion of the breakwater are shown in Figure 14, and detailed data obtained during the broken armor unit inventory are shown in Table 3. Armor unit numbers identified in Figure 14 correspond to those listed in Table 3. As shown, broken units occur along the entire length on the sea side of the structure, but in general, are more concentrated along the

Figure 14. Approximate locations of broken/cracked armor units along outer portion of Nawiliwili Harbor breakwater

seaward end of the breakwater. Sixty-one percent of the broken units are located on the outer half of the structure (sta 16+00 - 20+50), and about one third of the broken units are situated on the outer 45.7-m (150-ft) length of the breakwater (sta 19+00 - 20+50). With regard to distance from baseline, the majority of broken units (71 percent) are located between 7.6 and 16.8 m (25 and 55 ft) seaward of the baseline. These units are in the active wave zone.

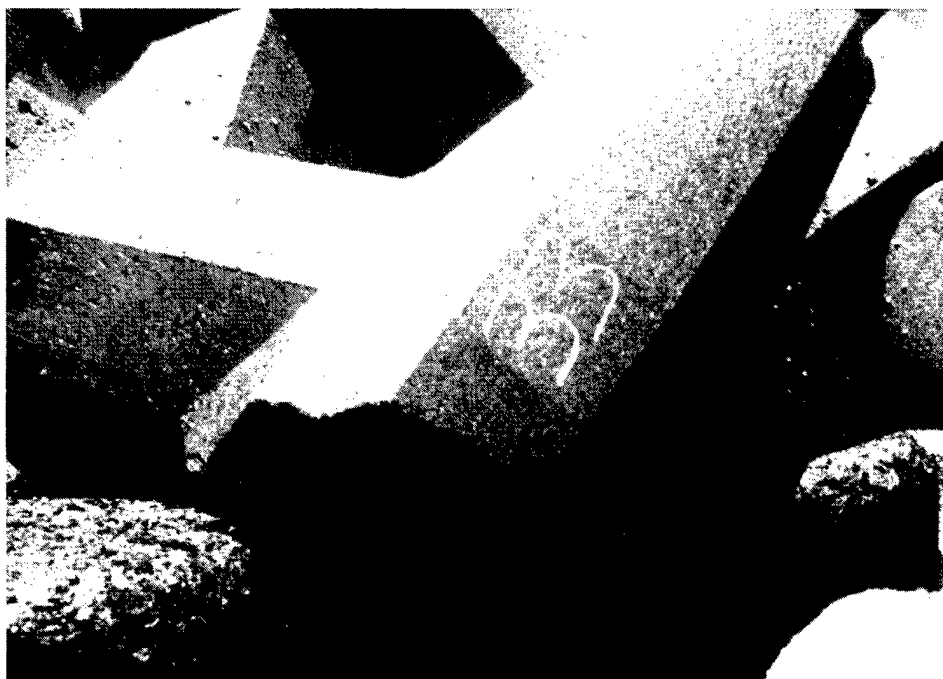
Types of breaks for the dolosse included shank and fluke breaks. These were characterized as mid-shank, shank-fluke (shank broken in vicinity of fluke), and fluke-shank (fluke broken off at junction with shank). Also recorded were straight breaks (broken straight across) and angled breaks (broken at some angle to the dolos limb). For the tribars, types of breaks included those through the center section of the unit where one or more legs were separated from the unit, and those in which just a portion of one of the legs was broken off. Views of representative types of breaks for the armor units are shown in Figures 15-18. Armor units with hairline cracks on one side were not counted; only those that were cracked all the way through were considered a break for recording purposes.

Figure 16. Dolos with fluke-shank break

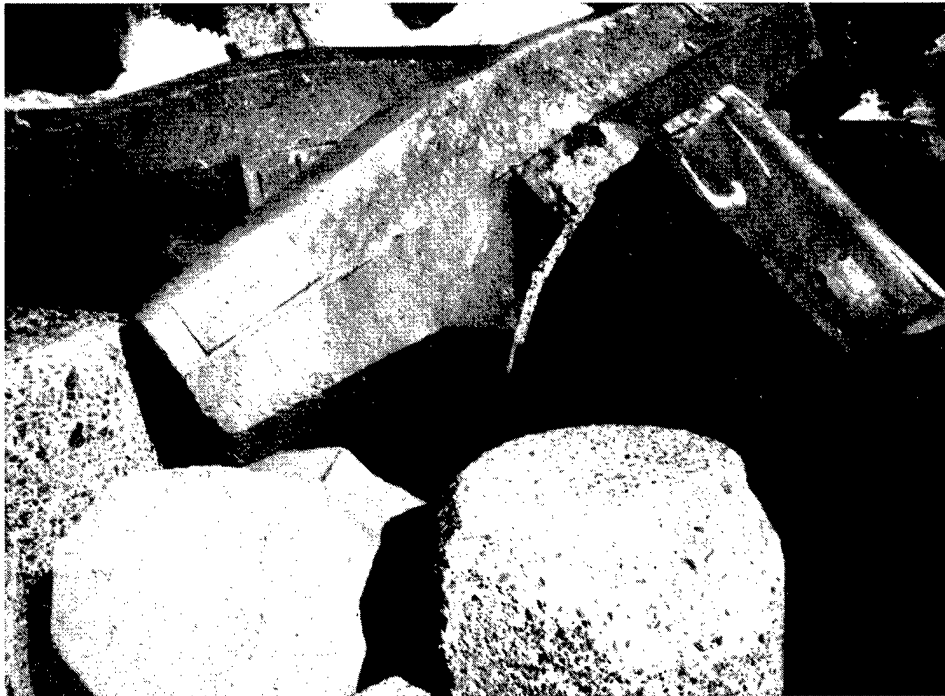
Figure 17. Dolos with shank-fluke break
